SUBJECT: Gulfco Marine Maintenance Superfund Site  
Condition of Storage Tanks and Former Impoundment Cap

On March 9, 2010, I performed an inspection of the above ground storage tanks and the cap over the former impoundments located at the Gulfco Marine Maintenance Superfund Site at 906 Marlin Avenue in Freeport, Brazoria County, Texas. Pictures of the tanks and cap are attached.

**GULFCO MARINE MAINTENANCE SUPERFUND SITE  
INSPECTION, MARCH 9, 2010**

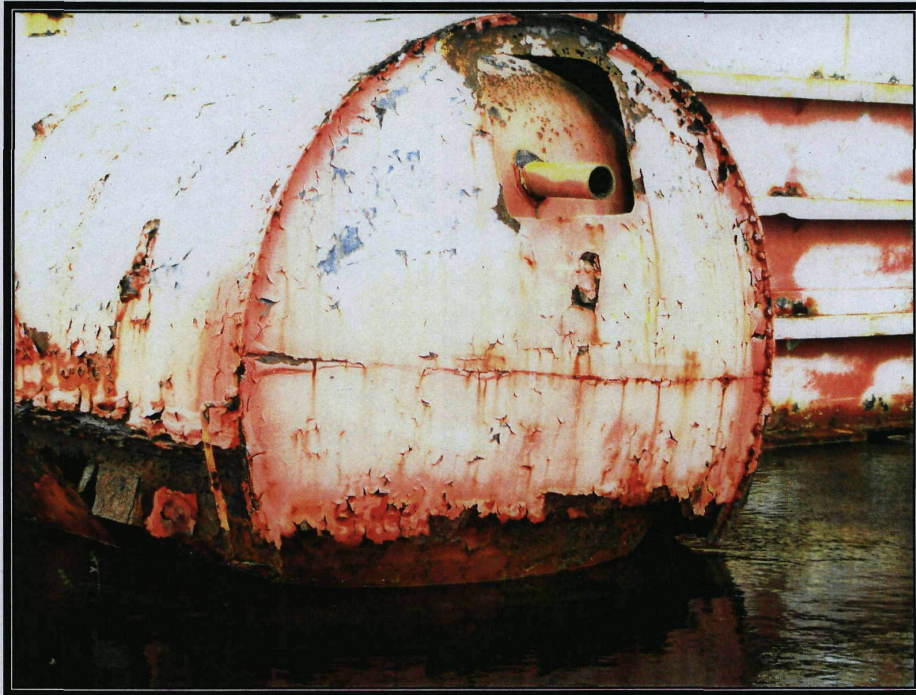
**Tank #2**

- (a) Tank No. 2 (organic phase, TCLP data):
  - Chloroform (2.25 mg/L)

- 1,2-Dichloroethane (8.4 mg/L)
- Trichloroethylene (1.52 mg/L)
- Vinyl Chloride (0.247 J mg/L)
- (b) Tank No. 13 (oily sludge, TCLP data)
  - Benzene (13.8 mg/L)
  - 1,2-Dichloroethane (2.73 J mg/L)
  - Tetrachloroethylene (47.7 mg/L)
  - Trichloroethylene (2.98 J mg/L)
- (c) Tank No. 18 (light organic phase, TCLP data)
  - Chloroform (216 mg/L)
  - Heptachlor (0.029 J mg/L)
- (d) Tank 21 (oily water, TCLP data)
  - Benzene (51.6 J mg/L)
  - Chloroform (2100 mg/L)
  - 1,2-Dichloroethane (224 mg/L)

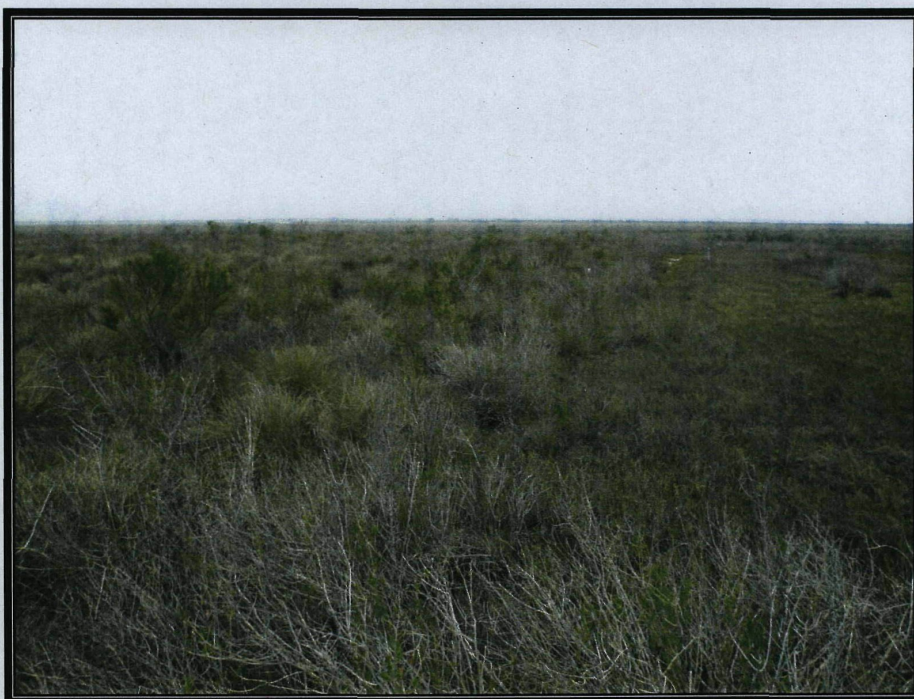
**Former Impoundment Cap: east corner, view northwest**

The purpose of the clay cap is to prevent direct exposure to the underlying hazardous substances, and to restrict infiltration of rain water and migration of the hazardous substances in the shallow groundwater. The cap was observed to have ruts on the top, and was covered in some areas by woody shrubs reaching a height of approximately three to four feet. These ruts may erode to the point of exposure of the contaminated materials below the cap. In addition, the ruts and the roots from the woody shrubs will likely result in increased infiltration through the cap, and migration of the hazardous substances beneath the cap into shallow ground water, the surrounding soils, and surface waters.

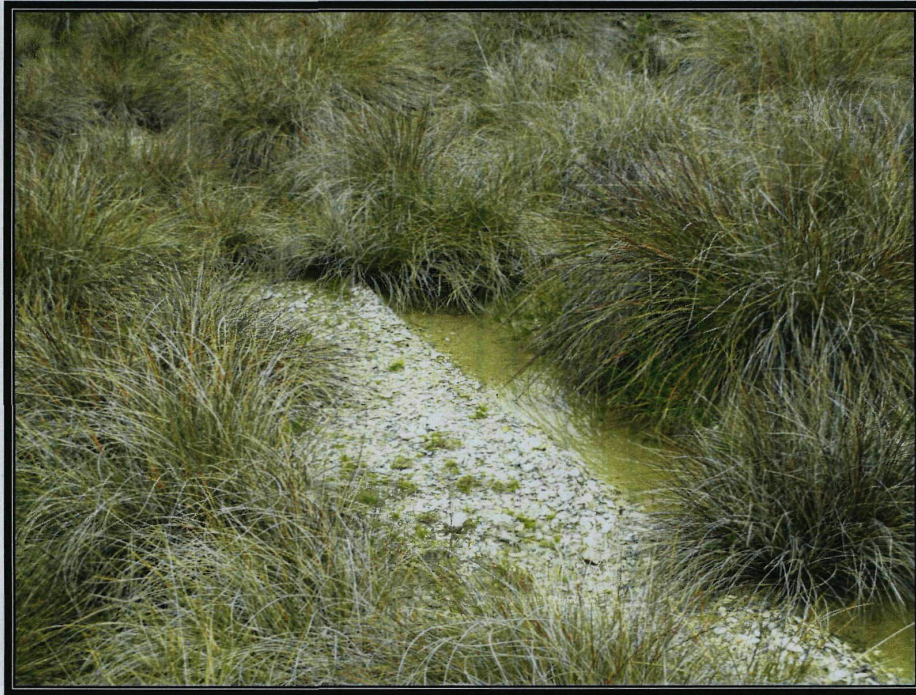
**Former Impoundment Cap: rut on top of west side of cap**

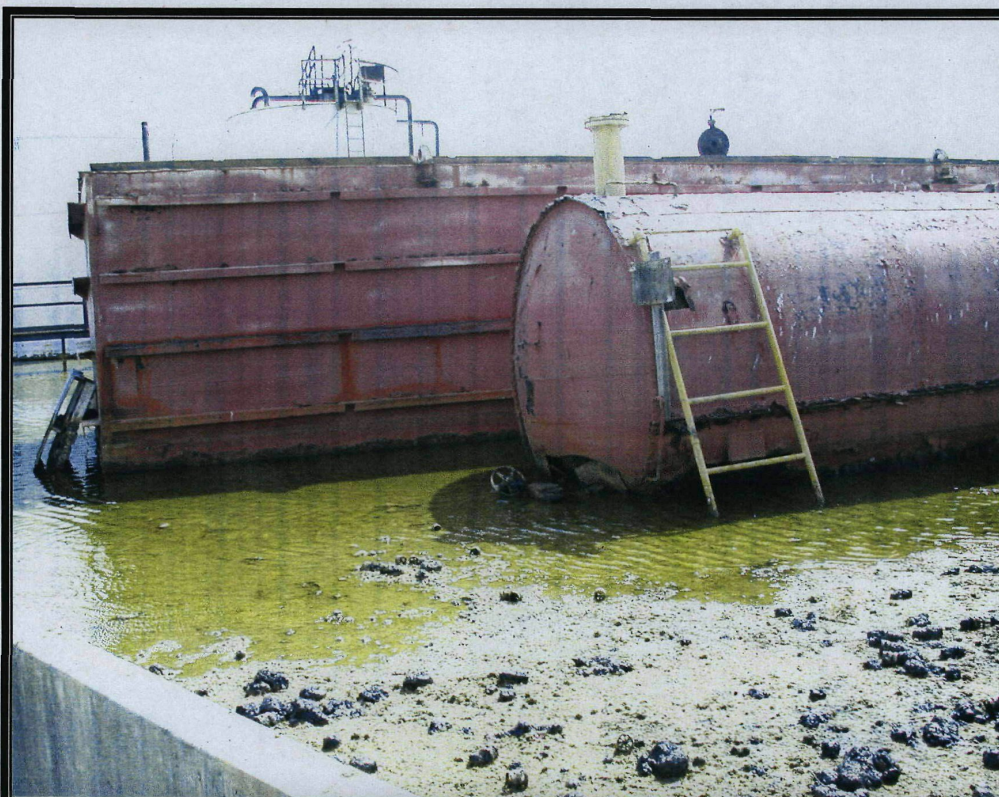
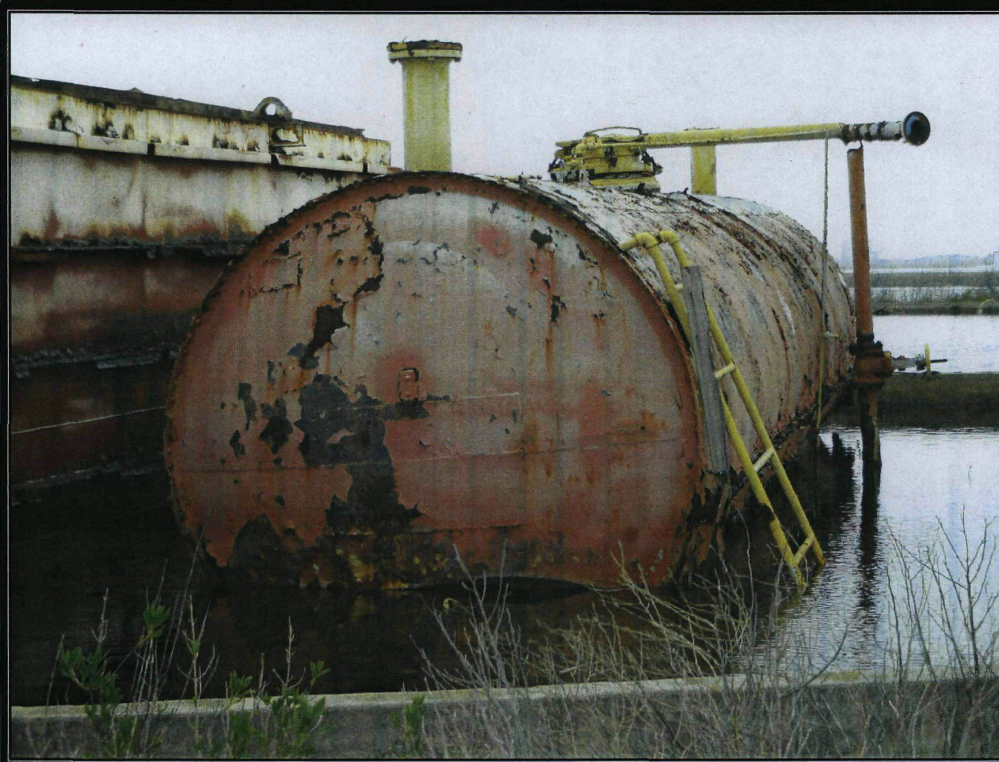
Gulfco Marine Maintenance Superfund Site  
Tank No. 2 (round tank)  
Top: May 2003; Bottom: March 2010

An above ground storage tank farm is located at the site south of Marlin Avenue. It consists of fourteen tanks of various sizes located within a concrete bermed area. In 2008, wind and/or storm surge resulting from Hurricane Ike removed a fifteenth tank. These tanks contain various hazardous substances including benzene, 1,2-dichloroethane, chloroform, heptachlor, tetrachloroethene, trichloroethene, and vinyl chloride. Corrosion was observed on the tanks which resulted in complete penetration of the metal in at least one case (Tank No. 2). The containment areas were approximately one-half full with water. Since 2003, there has been additional deterioration and corrosion of the tanks, including the tanks (Tank Nos. 2, 13, 18, and 21) that contain hazardous substances as identified below. Pictures of these four tanks taken in 2003 and 2010 are attached. This corrosion will continue as a result of the site's location near the coast, and will likely result in future releases as the tanks continue to deteriorate. In addition, the site's location within the 100-year floodplain and further tank deterioration make it likely that additional tanks could be washed away in future hurricanes.
